## FINDING OF SUITABILITY TO TRANSFER (FOST) FORT MCPHERSON, GEORGIA

MCPHERSON IMPLEMENTING LOCAL REDEVELOPMENT AUTHORITY PROPERTY

November 2013

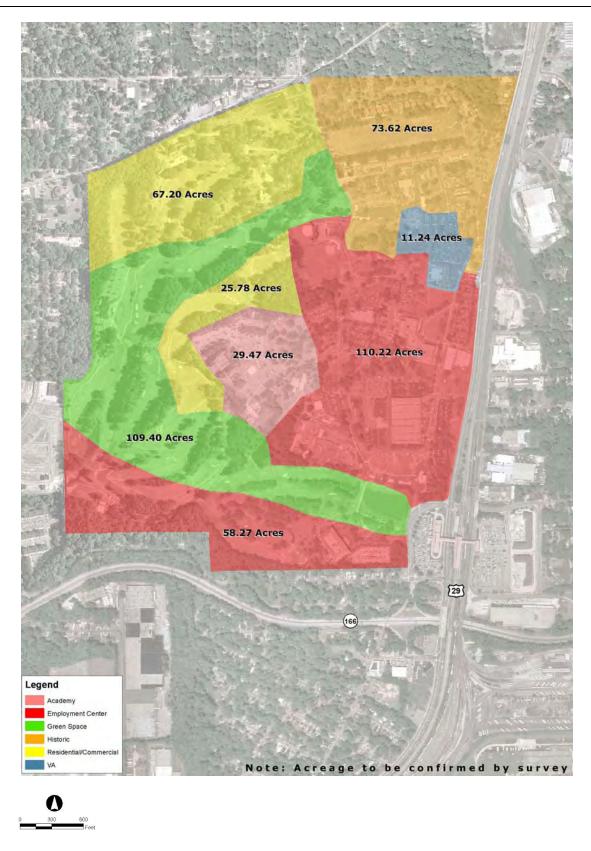
#### FIGURE 3

Source: Amended Land Use Plan, October 2012 (Jacobs Engineering Group, 2012)
